## Case Study

### PRIVATE LAKE

Near Ulm, by the River Danube  
Germany

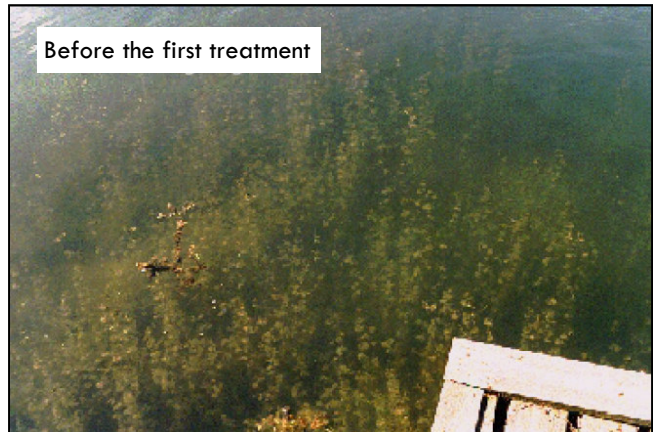
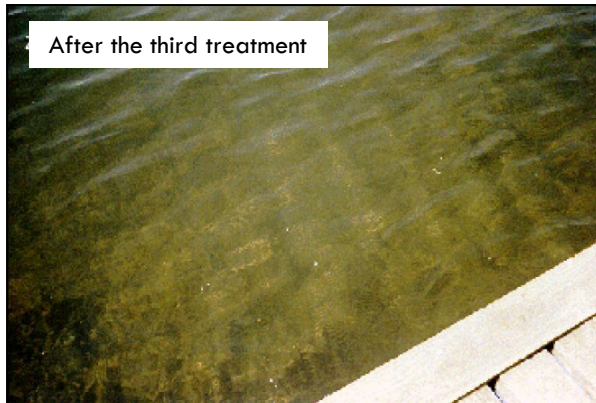
On 8 June 1998, Plocher Water Activator was applied. The whole lake was covered with blanketweed apart from a 20m radius area in the middle. Gas bubbles rose periodically from the sediment, which is why the blanketweed had been dislodged. There was less blanketweed and the visual depth had improved to 1.5m, and the mussels were clean.

The first treatment was undertaken on 16 May 1998: Plocher Bio-Waste Composter (AK 1551) was applied to the 1/2m thick slimy mud around the banks and Plocher Water Activator (AW 4031) was used across the surface of the water.

In mid-July 1998, Plocher Water Activator was re-applied. Observations on this day included a further reduction in blanketweed, the lakebed was less slimy and more solid, and the mud on the banks only reached the ankle.
